# **Mold & Moisture Intrusion Case Study Report**

National Center for Housing and the Environment

NAHB Research Center, Inc.

January 2004

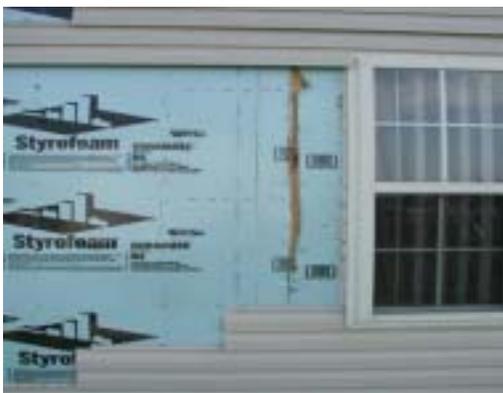
Vinyl siding without housewrap

While probably not the main source of moisture, the top of all vinyl corners should be flashed or sealed.

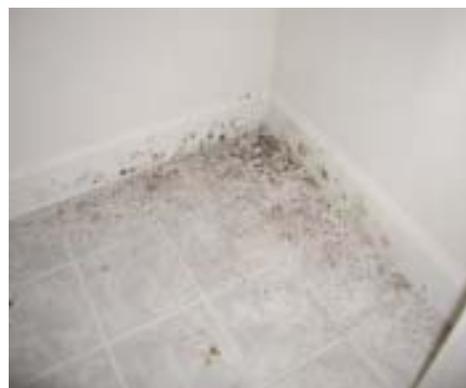
Mold on floor and baseboard

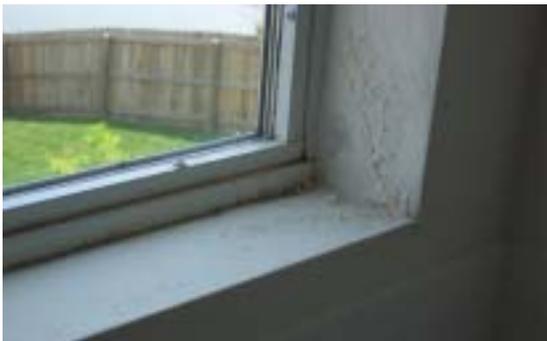
Water damage on window sill and frame

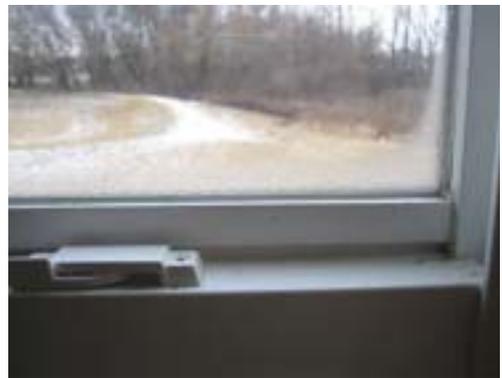
Window condensation in basement

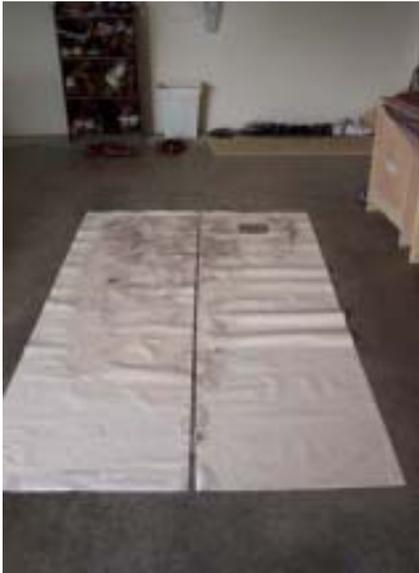
Mold on backside of vinyl wallpaper

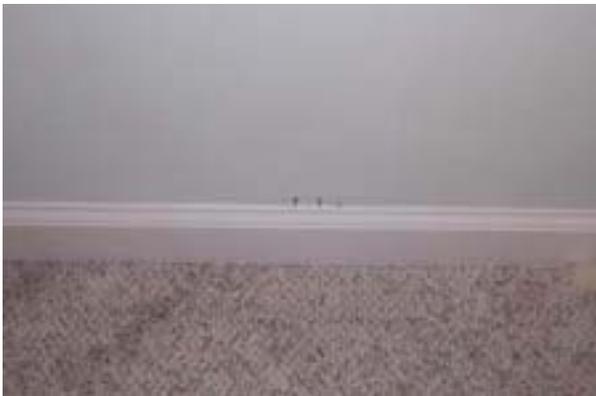
Pin holes in exterior walls where moisture readings were taken

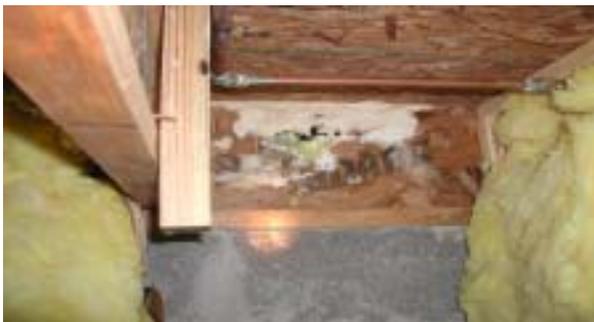
Mold on band joist below bedroom

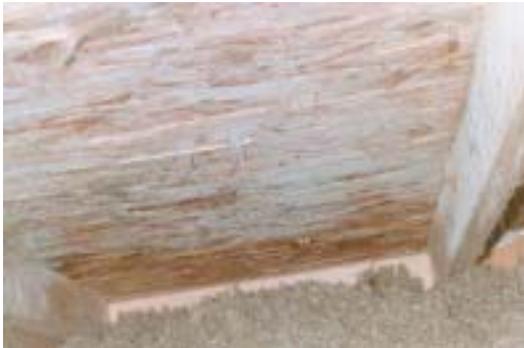
OSB roof sheathing with evidence of high moisture

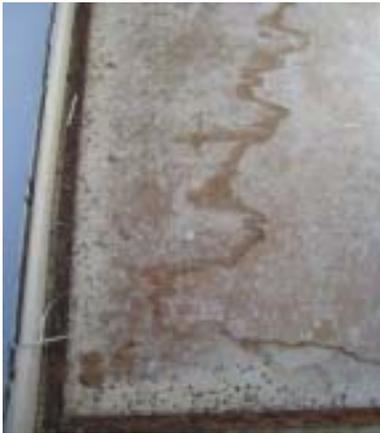
Water staining on floor below window

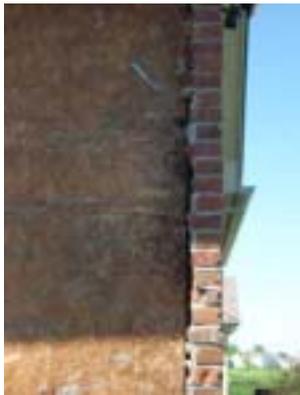
Inadequate air space between wood sheathing and brick veneer.

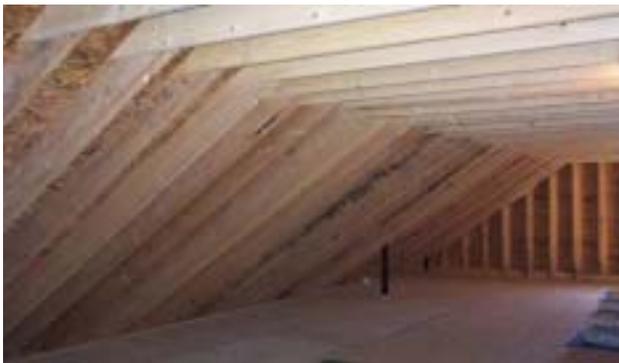
Attic and trusses with mold growth

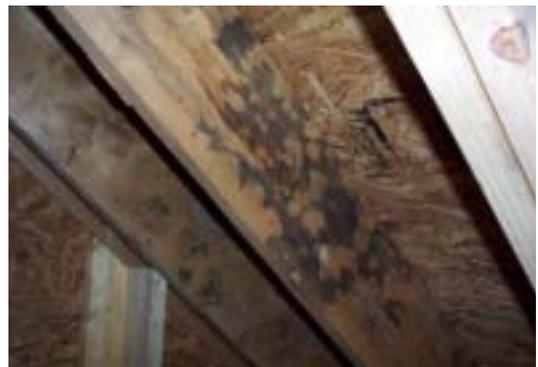
Trusses with mold growth

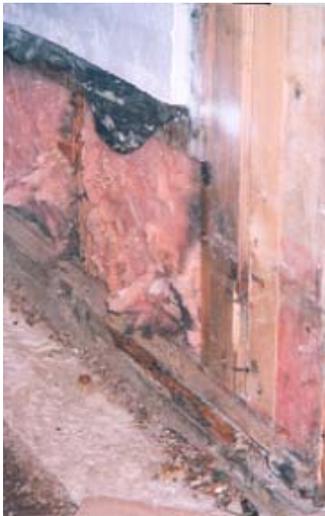
Untreated wood sill plate

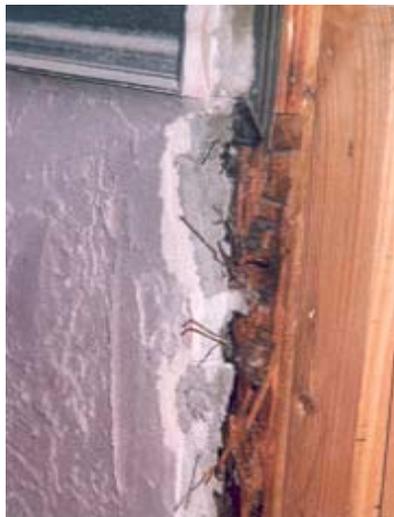
Water intrusion around window frame

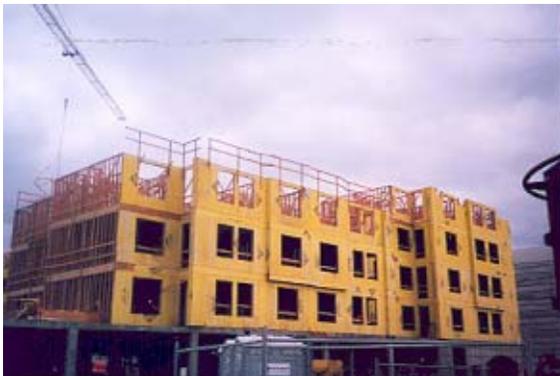
Unroofed, exposed construction

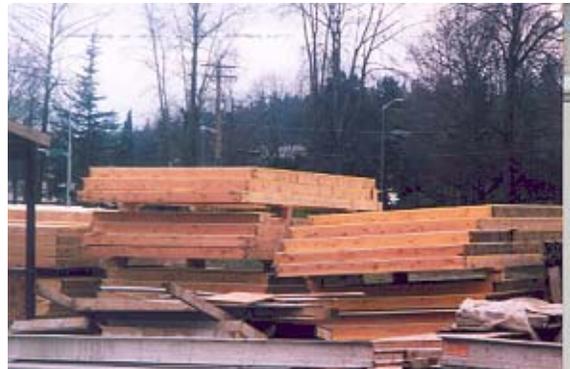
Wall panels exposed to weather

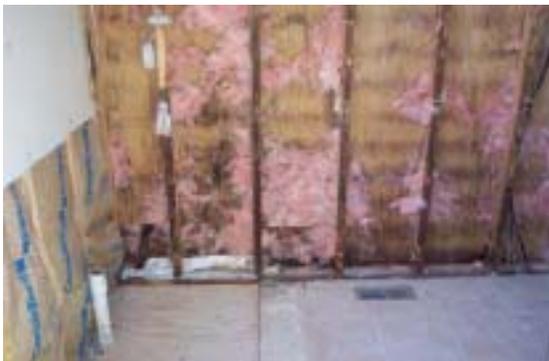
Moisture stains conform to the lap spacing in the exterior siding. Areas where the vapor barrier was breached (e.g., electrical outlets, staples, and drywall nails) show little sign of damage.
