# **Mold & Moisture Intrusion Case Study Report**

National Center for Housing and the Environment

NAHB Research Center, Inc.

January 2004

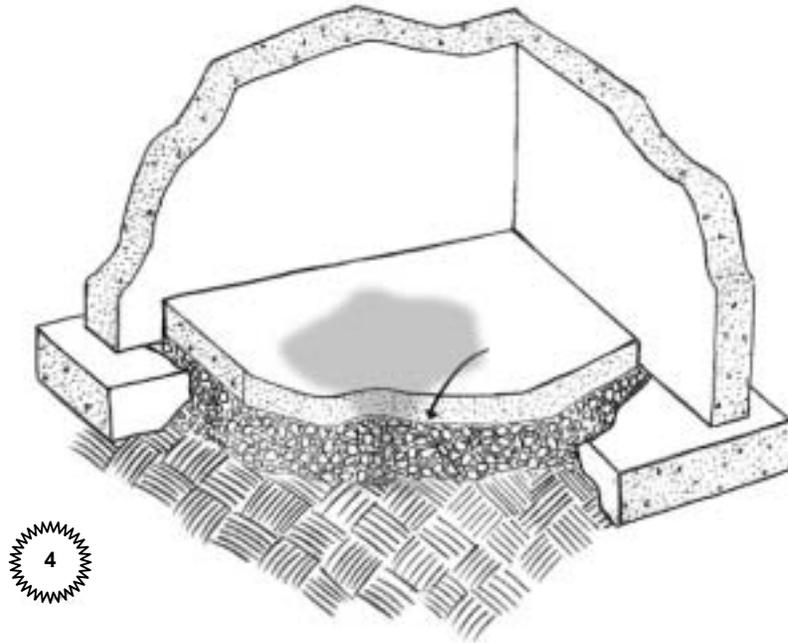
**Figure 3 Moisture Wicking from Under Slab**

- 4 Soil moisture wicking up through the concrete slab. Several actions can prevent this phenomenon. Properly grading soil (4% slope or more) away from the foundation and incorporating vapor barriers under the basement slab (see arrow in Figure 3) are two methods to minimize this problem.

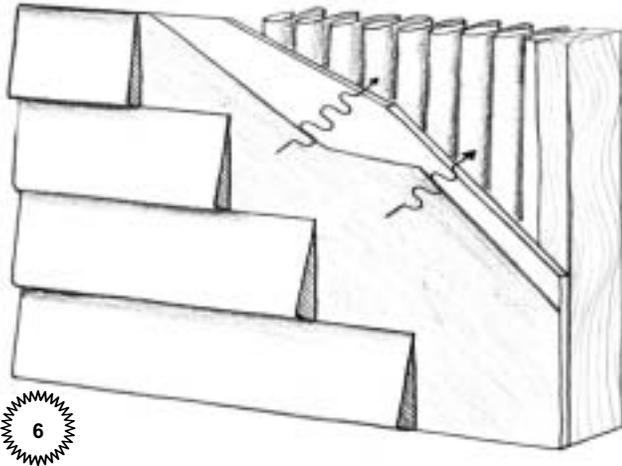
**Figure 4 Moisture Migration from Outside to Inside**

- 6 High humidity, outside air entering and condensing on wall cavity surfaces through diffusion. This can be a problem during the cooling season. Limiting the use of vapor barriers on the interior of the wall such as vinyl wallpaper will allow moisture that does enter walls to dry to the inside of the home. Allowing an air gap between exterior claddings and sheathing will help prevent moisture from diffusing into the wall cavity.

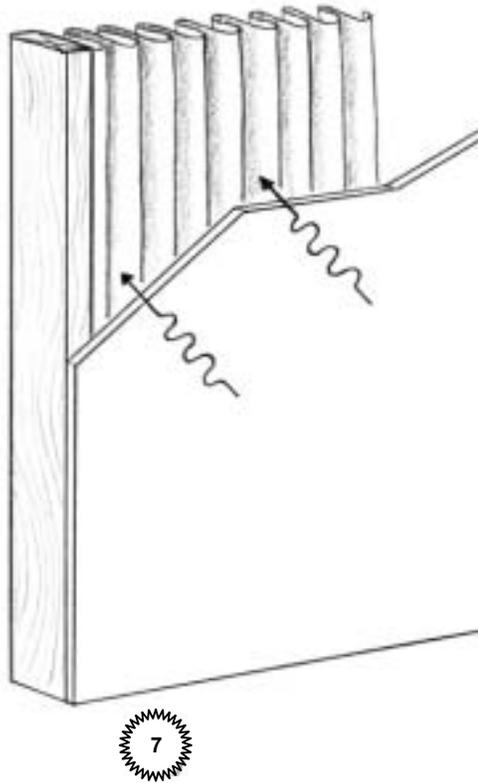
**Figure 5 Moisture Migration from Inside to Outside**

Moisture movement from the humid interior out through exterior walls and condensing in the wall cavity. This phenomenon occurs commonly during winter in heating climates. Keeping interior air relative humidity levels low, appropriate use of vapor retarders, and incorporating higher R-value measures such as more wall insulation and energy-efficient windows help control this problem.

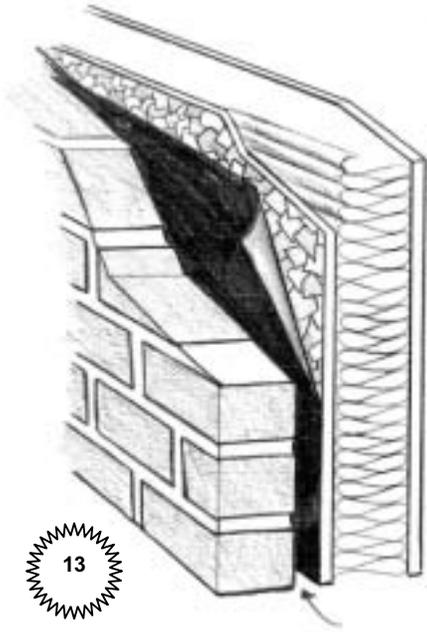
**Figure 6 Gap Between Exterior Cladding and Sheathing**

13 Air gap between exterior cladding and sheathing. The presence of an air gap can greatly reduce rain and water vapor from entering a wall cavity. Brick or masonry veneers are particularly troublesome for moisture movement from outside to inside the wall cavity. Maintaining an air gap and minimizing the occlusion of the gap by mortar or other substances helps prevent this problem.

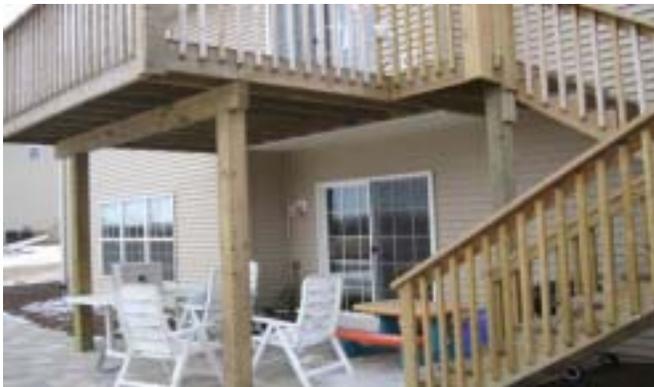
Walkout basement

Moisture was developing in the wall cavities and on windows in the basements. Investigators studied three test homes. The outside air temperature on the day of the visit was 17°F; the following measurements were obtained:

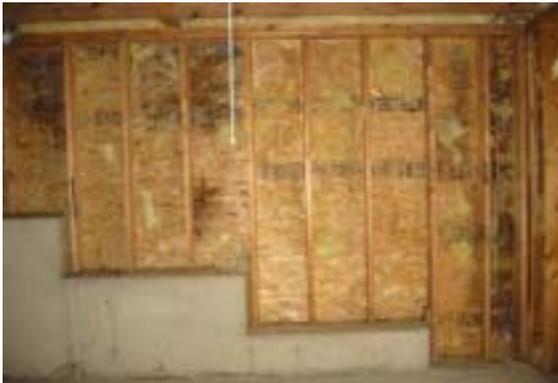
Stepped framed basement walls

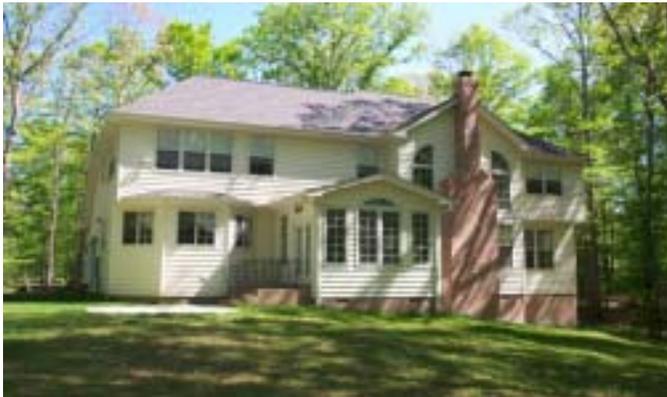
Perimeter grade sloping away from structure

The bottom side of the insulation between the floor joists was dripping wet. The moisture range of the bottom plate of the floor joists was 20% to 24%. Below grade sections of the foundation wall surfaces were visually wet. Pools of water were observed on the vapor barrier ground cover. Water was dripping off the HVAC supply plenum insulation covering. Two fans, each running at approximately 100 cubic feet per minute were actively venting the crawlspace and the grills of the passive vents were open.

Ventilating the cool crawlspace with humid outdoor air introduced moisture which condensed in the crawl space. Field personnel placed air temperature and moisture sensors in the basement. They also disabled the crawl space ventilation fans, closed the crawl space passive vent grills, placed a dehumidifier in the crawl space, and sealed perimeter wall vents with insulation.

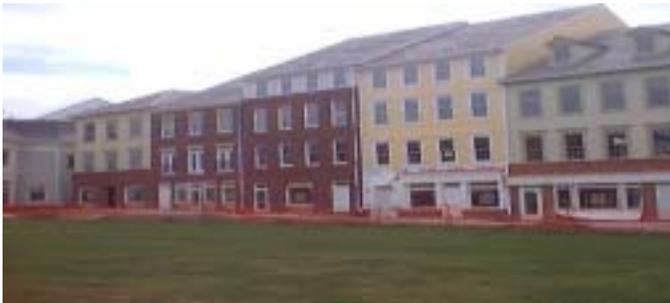
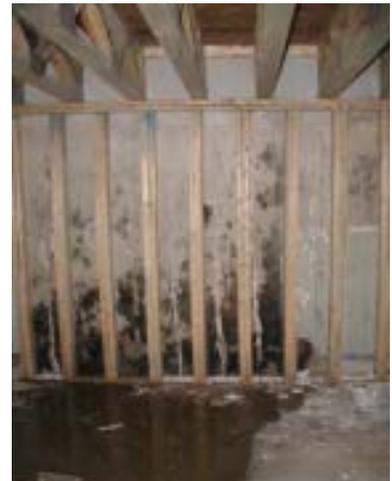
The shaft walls exhibited active mold growth. The shaft- or firewall is typically exposed to the weather for eight or more weeks before protected by roof sheathing. The wall assembly absorbs considerable moisture. The basement receives little ventilation once the first floor is set. There are no proactive steps (e.g., fans, dehumidifiers, sump pumps) taken to dry the basement and the soil has poor drainage.

Precipitation is the primary source of moisture. Severely molded material was removed and replaced. The remaining affected material was cleaned with X-14 (a mildew stain remover) and painted with Kilz brand primer. Dehumidifiers were added in the basement area and plastic sheeting was used to cover the assembly. On remaining projects, a 10-inch masonry stem wall was added to lift the wall assembly off of the floor to prevent standing water from wicking into the construction materials.

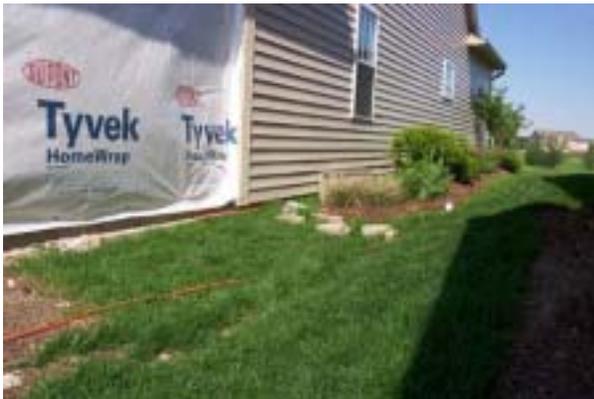
Housewrap over sheathing.

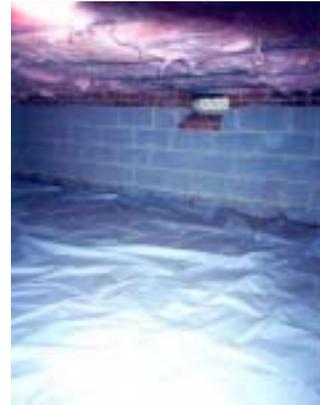
Vented crawlspace with ground vapor retarder and fiberglass batt insulation between joists

The vented crawlspace has several areas where the joist or wall temperatures were near or at the dew point, a condition that promotes mold growth. The unvented crawlspace showed joist temperatures consistently above the dew point indicating a low probability for condensation and mold. Wall temperatures for the unvented crawlspace are not shown due to the inability of this experimental design to obtain dew point temperatures for air under the fiberglass insulation and near the masonry block wall. It is likely, however, that the condensation potential for the walls is also reduced.

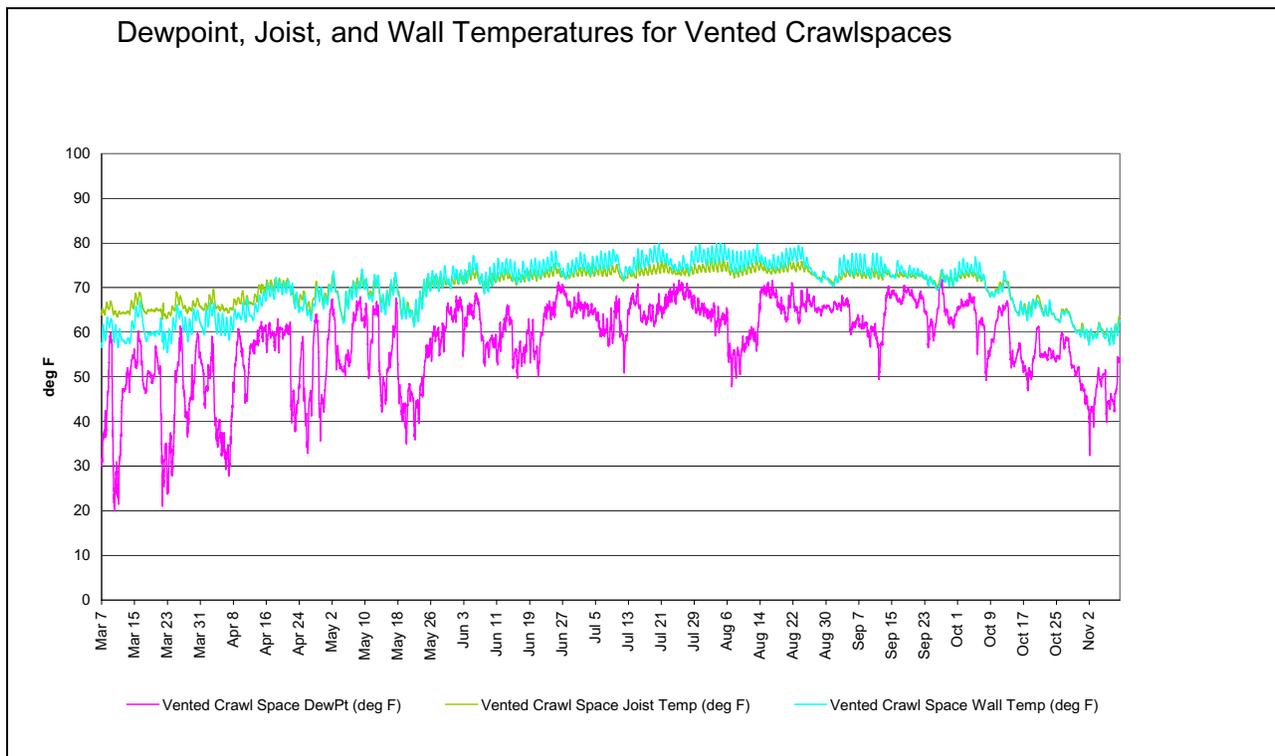
Each crawlspace was outfitted with sensors to record temperature and relative humidity of the air near wall surfaces, floor joists, and general ambient conditions of the space. The following graphs represent the conditions for vented and unvented crawlspaces respectively.

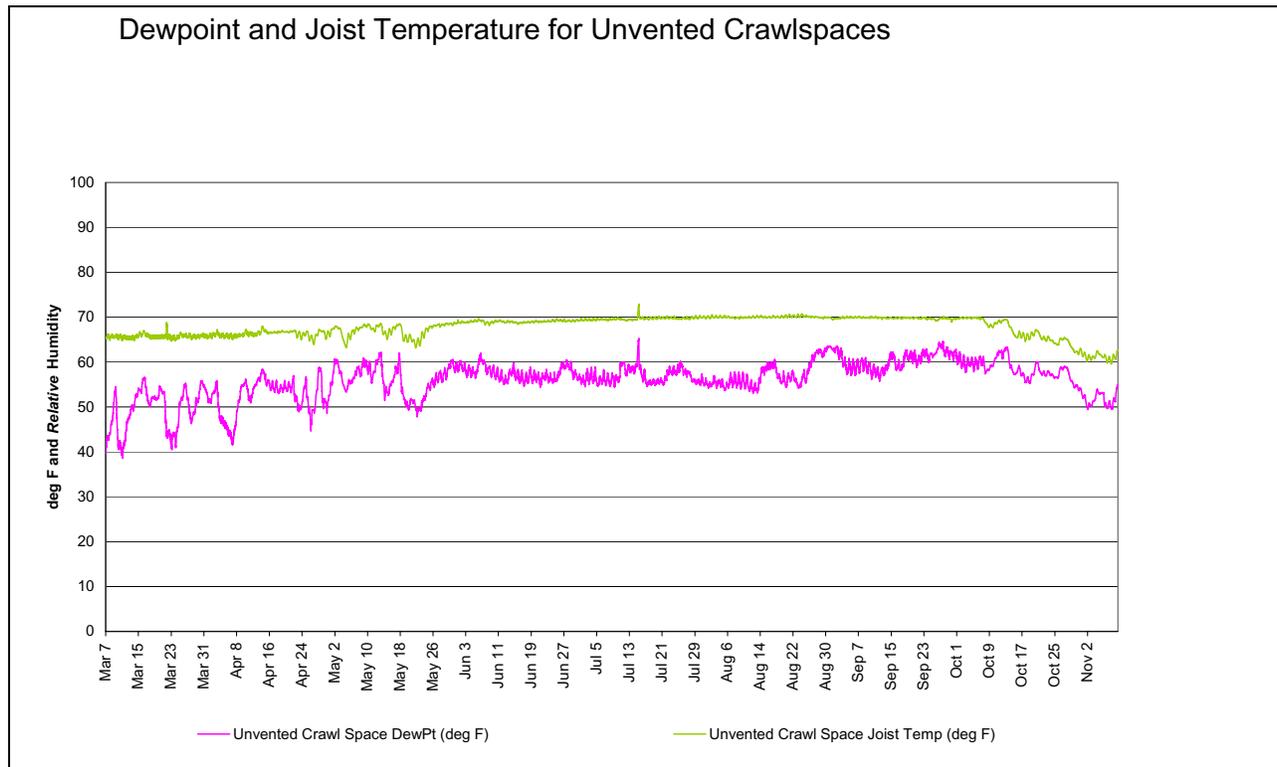
Readings for temperature and relative humidity were taken every fifteen minutes for about 8 months.
